Lot 2 Clarkes Lane Wangaratta  
Preliminary Arboricultural Report

2047 clar1221\_PAR

13 January 2022

31 May 2023

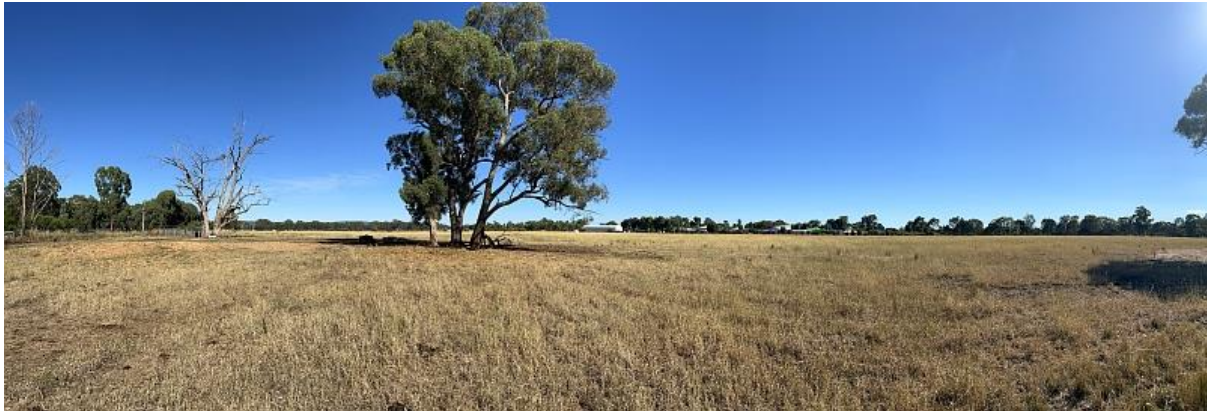
*Plate 1: Typical panorama of the subject site – open farmland with a few scattered remnant trees.*

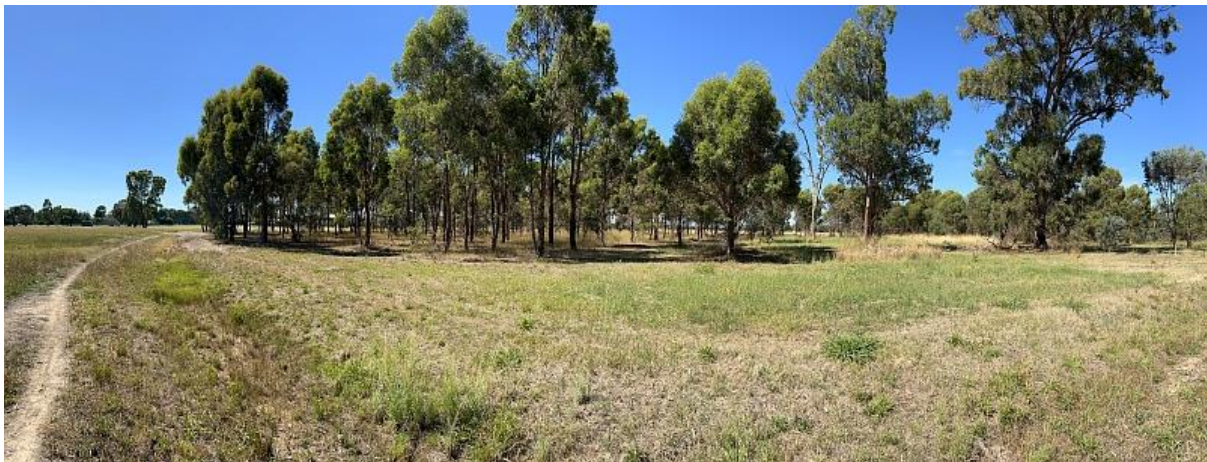
*Plate 2 Planted vegetation to the south-east of Wenham's Lane Reserve, with a few scattered remnant trees.*

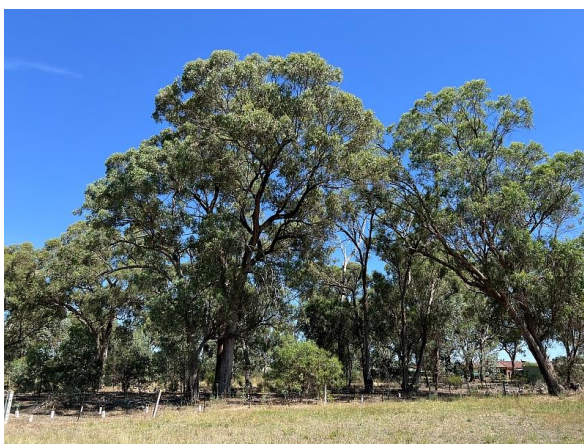
*Plate 3 Wenham's Lane Reserve*
