Lot 2 Clarkes Lane Wangaratta Preliminary Arboricultural Report

2047 clar1221\_PAR

16 July 2024

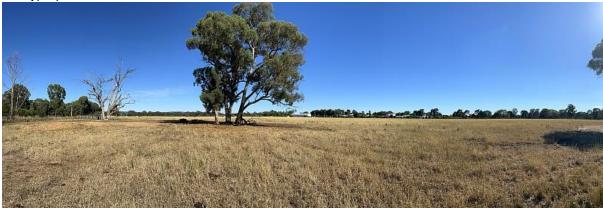
Plate 1: Typical panorama of the subject site - open farmland with a few scattered remnant trees.

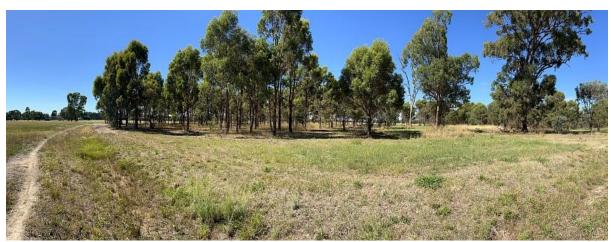
Plate 2 Planted vegetation to the south-east of Wenham's Lane Reserve, with a few scattered remnant trees.
