Rural City of  
**Wangaratta**

# Draft Rear Cambridge Drive Management Plan

2021

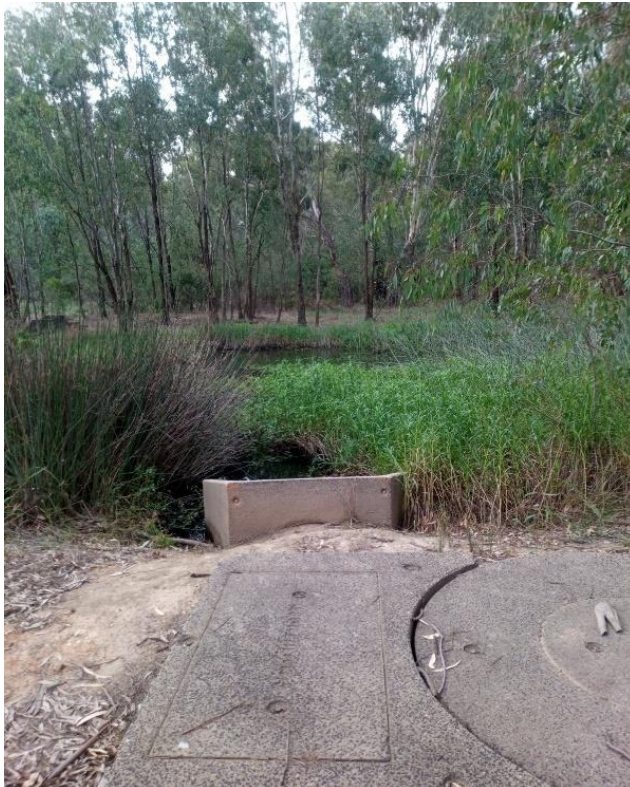
*Photo – Phillipson St Wetland Stormwater*

The Phillipson Street Wetland Stormwater basin that was already constructed at the site was eroding away at the edges. Jute matting was placed around the edge of the basin and replanted with native species including groundcovers. Some of the species found in and around the retention basin include:

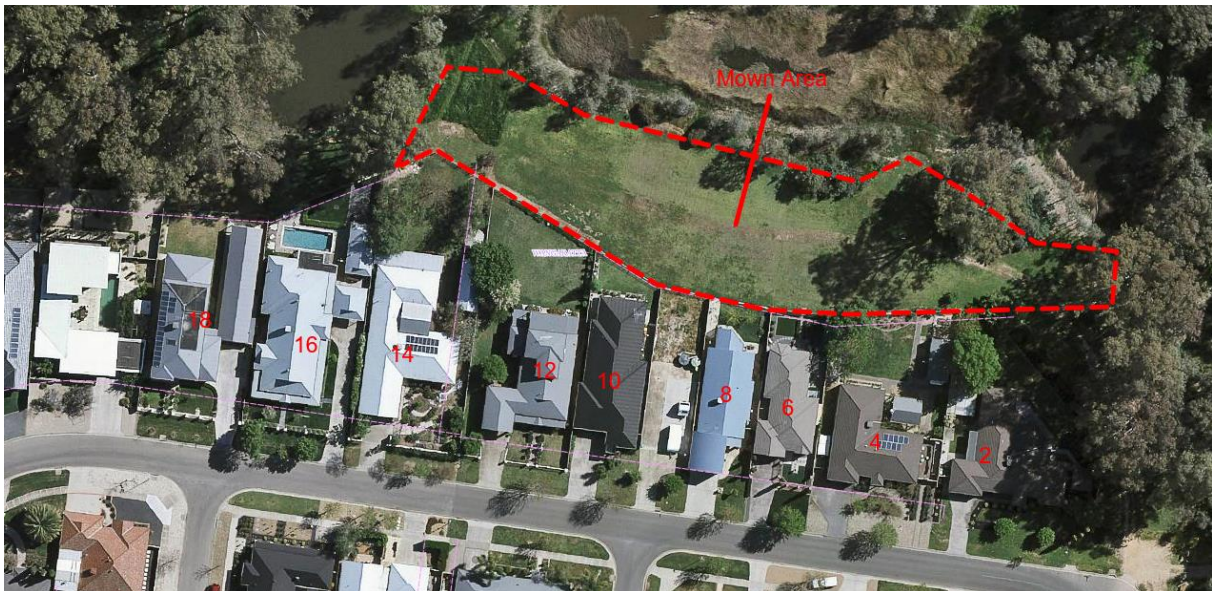
*Map – Area mowed by Council staff*

1. The Rural City of Wangaratta to mow the buffer area behind property numbers 2 through to 14 throughout the year (depending on season) to keep grass short. Residents may only undertake extra mowing in this area no further than 6 metres from their boundary fence and only where grass occurs.

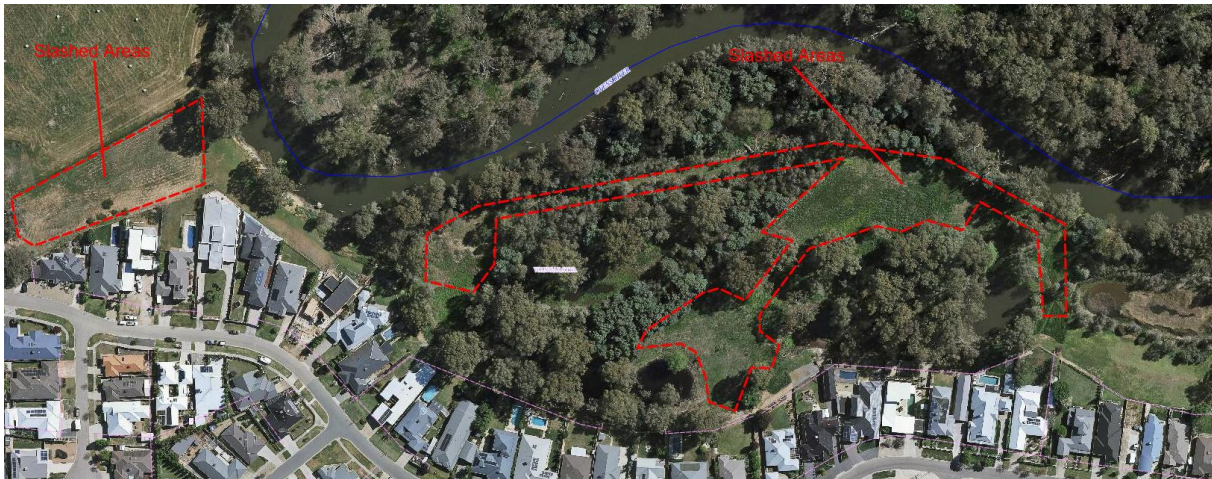
**Map – Area slashed by Council staff**

5. Slash woodland as required annually where pasture grasses (esp. *paspalum*) predominate to prevent heavy build-up of grassy fuel. The area covered by slashing activities to change overtime as revegetation occurs through the site and if inaccessible due to high water levels.
  - a. -Retain stubble of 100mm when slashing - to protect & encourage native species.
  - b. -Avoid where possible slashing areas where there is fallen timber or too close to lagoon edges and tree trunks.

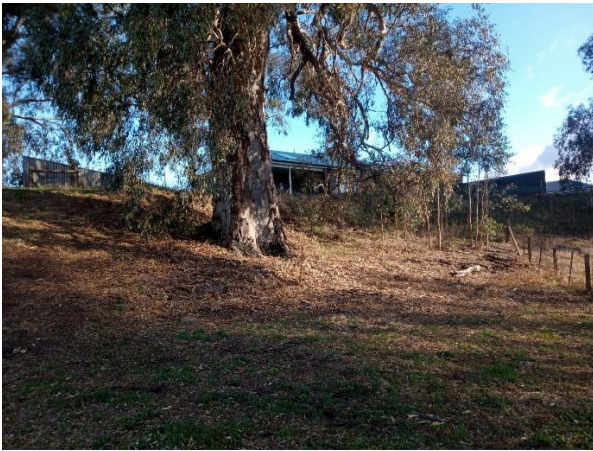
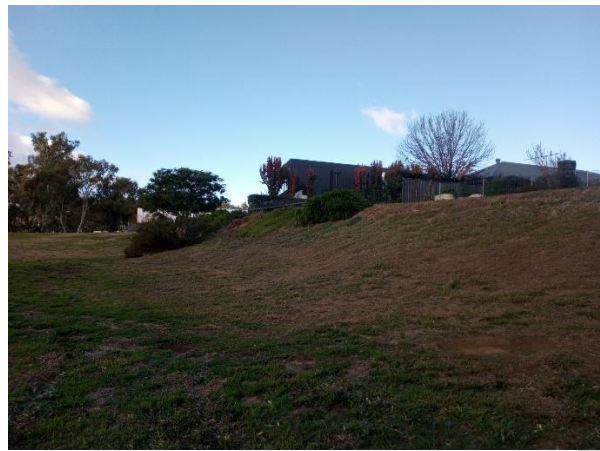
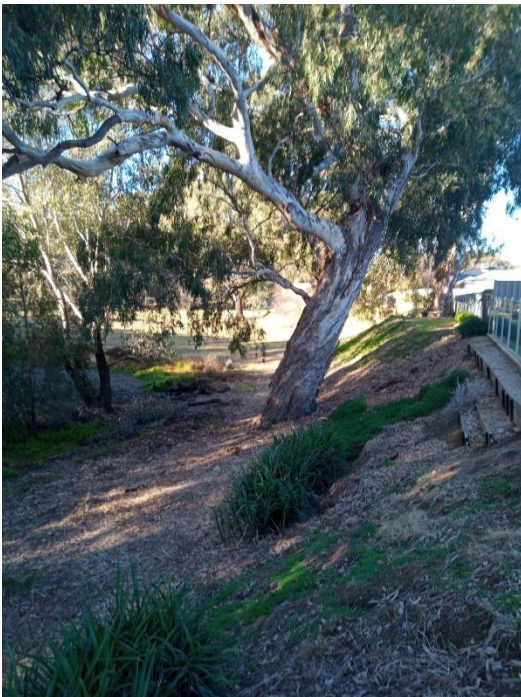
*Photos – Sloping areas Rear of Cambridge Drive*

The rear of properties 20 through to 66 (including No 2 Macquarie Court) have different levels of sloping from the rear of their boundary fences. Some areas are beginning to show signs of erosion. These slopes are too difficult to mow or slash and continued spraying of weeds remove vegetation cover eventually leading to further erosion.

1. The Rural City of Wangaratta to undertake planting of the sloping areas with native groundcovers listed below, these are all creepers and wont block views:
  - *Hardenbergia violacea* – Purple Coral Pea, Happy Wanderer.
  - *Myoporum parvifolium* – Creeping Boobialla.
  - *Kennedia prostrata* --Running Postman
2. Undertake revegetation along the section of the Ovens River that is showing signs of erosion and has very little vegetation to stabilise the bank. These plantings will consist of river and creek species used throughout the site and listed on page 5.

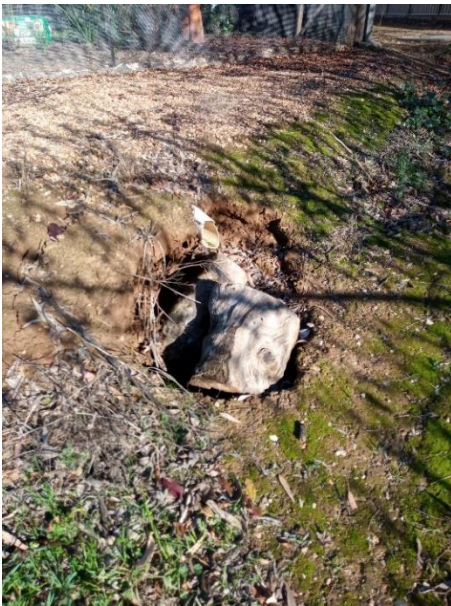
**Photo – Private landholder pipe installation causing erosion**

Some areas are further being eroded from the installation of privately owned water runoff pipes. There have also been instances where the runoff from these unapproved pipes has killed off all the ground layer vegetation.

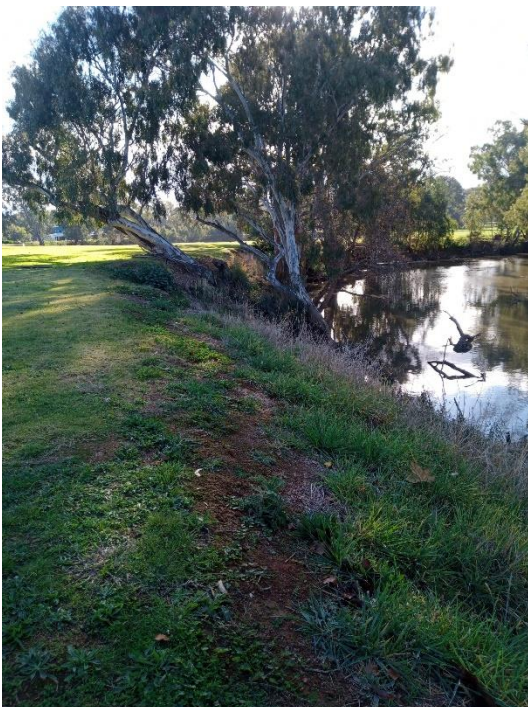
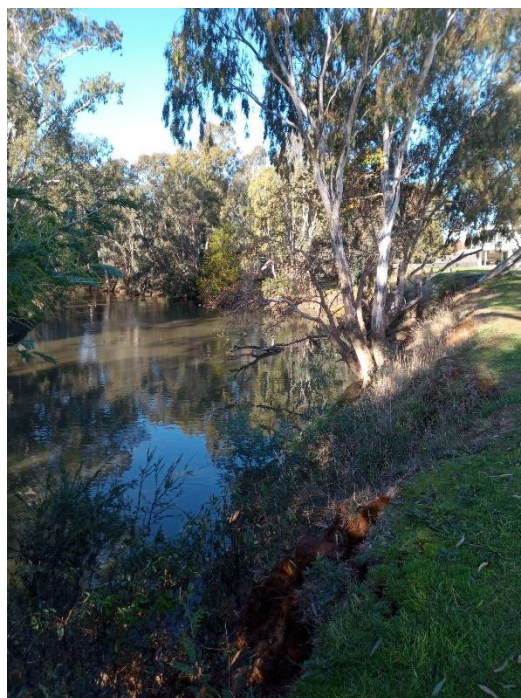
**Photo – Ovens River behind properties 52 to 54**

The bank of the Ovens River behind properties 52 and 54 is also showing signs of erosion and has minimal vegetation present and would benefit from revegetation works to stabilise the bank.

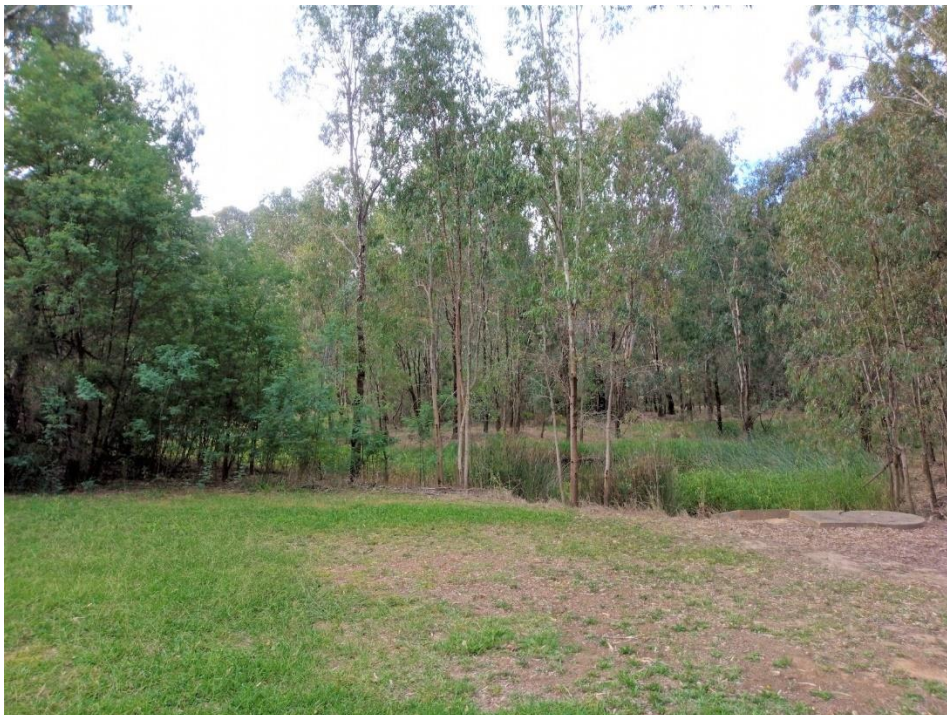
*Photo – Phillipson St Wetland*

The wetland catches water run-off from local roads and houses. The water passes through a Gross Pollutant Trap where litter is captured. The first pond in the wetland captures any sediment from stormwater. The second pond has a variety of native aquatic plants that works to filter out pollutants contained in the stormwater. The water that overflows from the stormwater wetlands into the Ovens River is of significantly improved quality.
